Single Survey

Property address	Gynach, Station Road, Barry, Carnoustie, DD7 7RS
Customer	Mr & Mrs Gillespie
Customer address	Gynach, Station Road, Barry, Carnoustie, DD7 7RS
Prepared by	J & E Shepherd
Date of inspection	12th April 2022

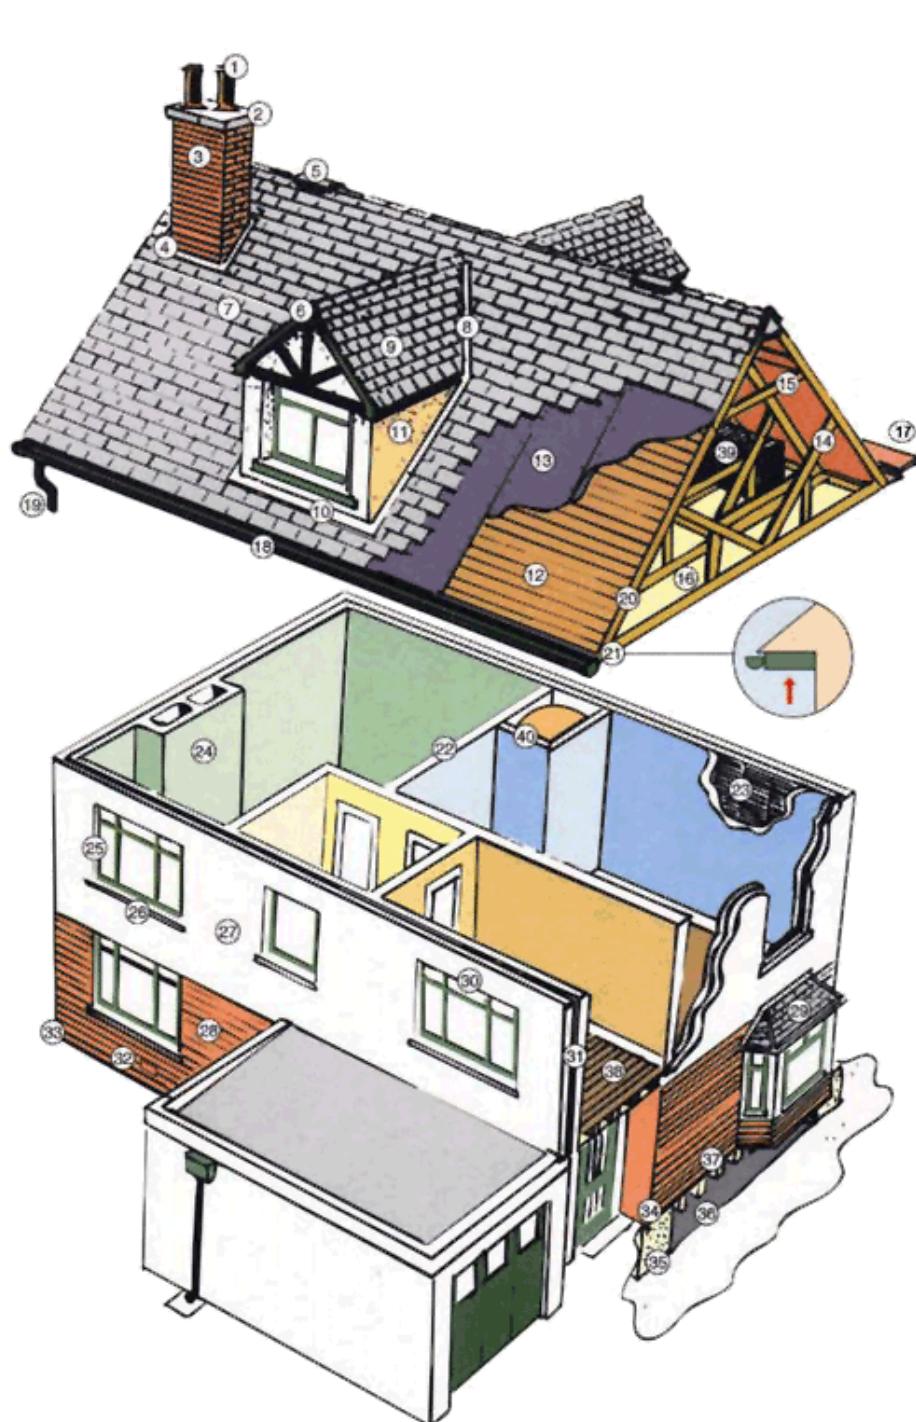
Sectional Diagram showing elements of a typical house

- ① Chimney pots
- ② Coping stone
- ③ Chimney head
- ④ Flashing
- ⑤ Ridge ventilation
- ⑥ Ridge board
- ⑦ Slates / tiles
- ⑧ Valley guttering
- ⑨ Dormer projection
- ⑩ Dormer flashing
- ⑪ Dormer cheeks
- ⑫ Sarking
- ⑬ Roof felt
- ⑭ Trusses
- ⑮ Collar
- ⑯ Insulation
- ⑰ Parapet gutter
- ⑱ Eaves guttering
- ⑲ Rainwater downpipe
- ⑳ Verge boards /skews
- ㉑ Soffit boards
- ㉒ Partition wall
- ㉓ Lath / plaster
- ㉔ Chimney breast
- ㉕ Window pointing
- ㉖ Window sills
- ㉗ Rendering
- ㉘ Brickwork / pointing
- ㉙ Bay window projection
- ㉚ Lintels
- ㉛ Cavity walls / wall ties
- ㉜ Subfloor ventilator
- ㉝ Damp proof course
- ㉞ Base course
- ㉟ Foundations
- ㉞ Solum
- ㉞ Floor joists
- ㉞ Floorboards
- ㉞ Water tank
- ㉞ Hot water tank

Reference may be made in this report to some or all of the above component parts of the property. This diagram may assist you in locating and understanding these items.
