Home Report

17 A The Esplanade
Broughty Ferry
Dundee
DD5 2EL

single survey

Property address	17 A The Esplanade Broughty Ferry Dundee DD5 2EL
Customer	Katherine Ferrier
Prepared by	Graham + Sibbald LLP

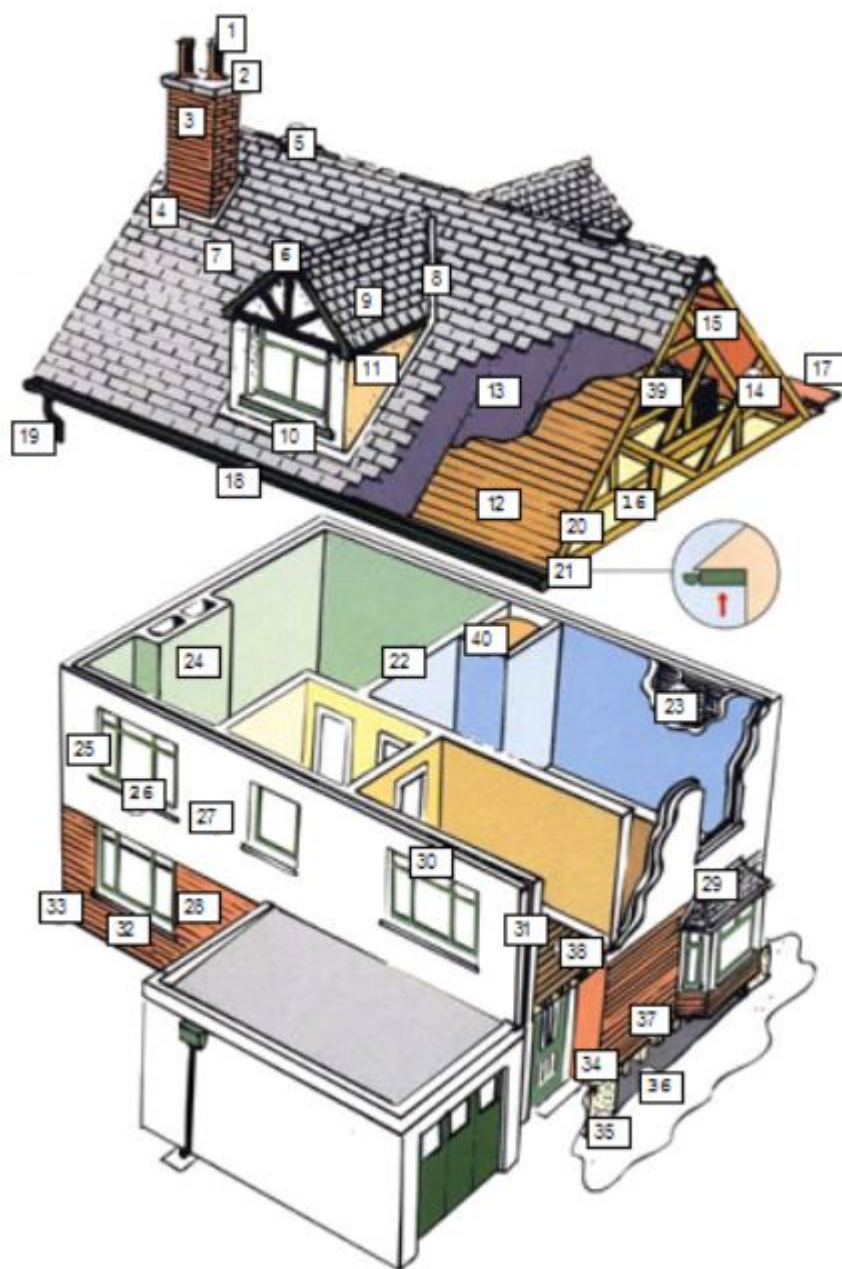
Sectional Diagram showing elements of a typical house

1	Chimney pots
2	Coping stone
3	Chimney head
4	Flashing
5	Ridge ventilation
6	Ridge board
7	Slates/tiles
8	Valley guttering
9	Dormer projection
10	Dormer flashing
11	Dormer cheeks
12	Sarking
13	Roof felt
14	Trusses
15	Collar
16	Insulation
17	Parapet gutter
18	Eaves guttering
19	Rainwater downpipe
20	Verge boards / skewes
21	Soffit boards
22	Partition wall
23	Lath / plaster
24	Chimney breast
25	Window pointing
26	Window sills
27	Rendering
28	Brickwork / pointing
29	Bay window
30	Lintels
31	Cavity walls / wall ties
32	Subfloor ventilator
33	Damp proof course
34	Base course
35	Foundations
36	Solum
37	Floor joists
38	Floorboards
39	Water tank
40	Hot water tank

Reference may be made in this report to some or all of the above component parts of the property. This diagram may assist you in locating and understanding these items.
