Home Report

2 Aberfoyle Gardens Broughty Ferry Dundee DD5 3EE

single survey

survey report on:

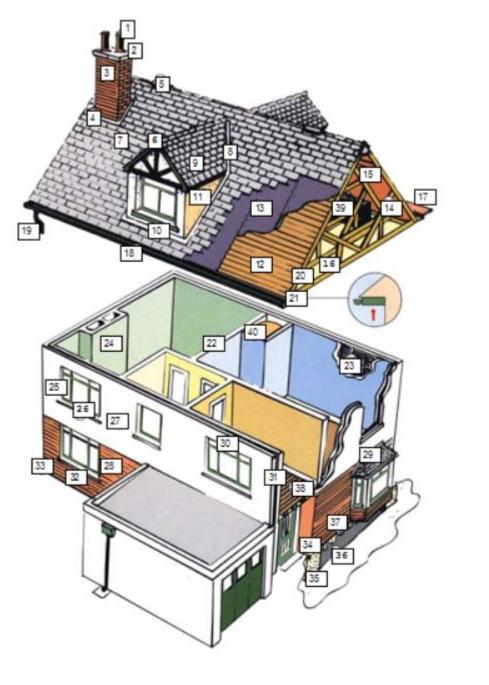
Sectional Diagram showing elements of a typical house

Reference may be made in this report to some or all of the above component parts of the property. This diagram may assist you in locating and understanding these items.
