Home Report

Moiben Main Street
Barry Carnoustie DD7 7RP

single survey

Property address	Moiben Main Street Carnoustie DD7 7RP
Customer	Joe Duncan
Prepared by	Graham + Sibbald LLP

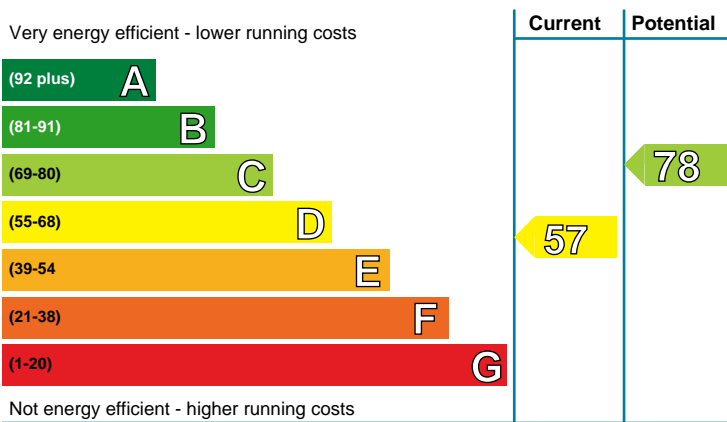
Energy Efficiency Rating

This graph shows the current efficiency of your home, taking into account both energy efficiency and fuel costs. The higher this rating, the lower your fuel bills are likely to be.

Your current rating is **band D (57)**. The average rating for EPCs in Scotland is **band D (61)**.

The potential rating shows the effect of undertaking all of the improvement measures listed within your recommendations report.

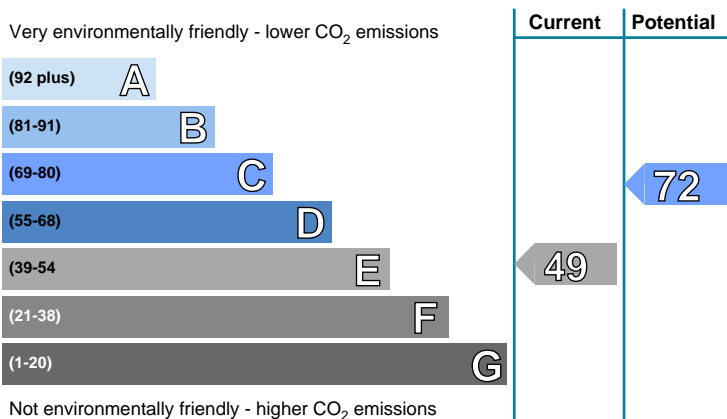
Environmental Impact (CO₂) Rating

This graph shows the effect of your home on the environment in terms of carbon dioxide (CO₂) emissions. The higher the rating, the less impact it has on the environment.
