# Home Report

269 Perth Road  
Dundee DD2 1JP

# single survey

survey report on:

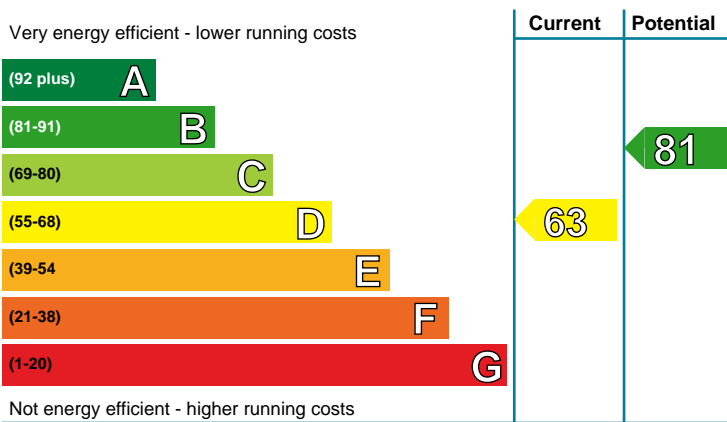
## Energy Efficiency Rating

This graph shows the current efficiency of your home, taking into account both energy efficiency and fuel costs. The higher this rating, the lower your fuel bills are likely to be.

Your current rating is **band D (63)**. The average rating for EPCs in Scotland is **band D (61)**.

The potential rating shows the effect of undertaking all of the improvement measures listed within your recommendations report.
